# **The Road Inventory of Tishomingo National Fish Hatchery Tishomingo, OK**

Prepared By:  
Federal Highway Administration  
Central Federal Lands Highway Division  
December 2009

## Tishomingo

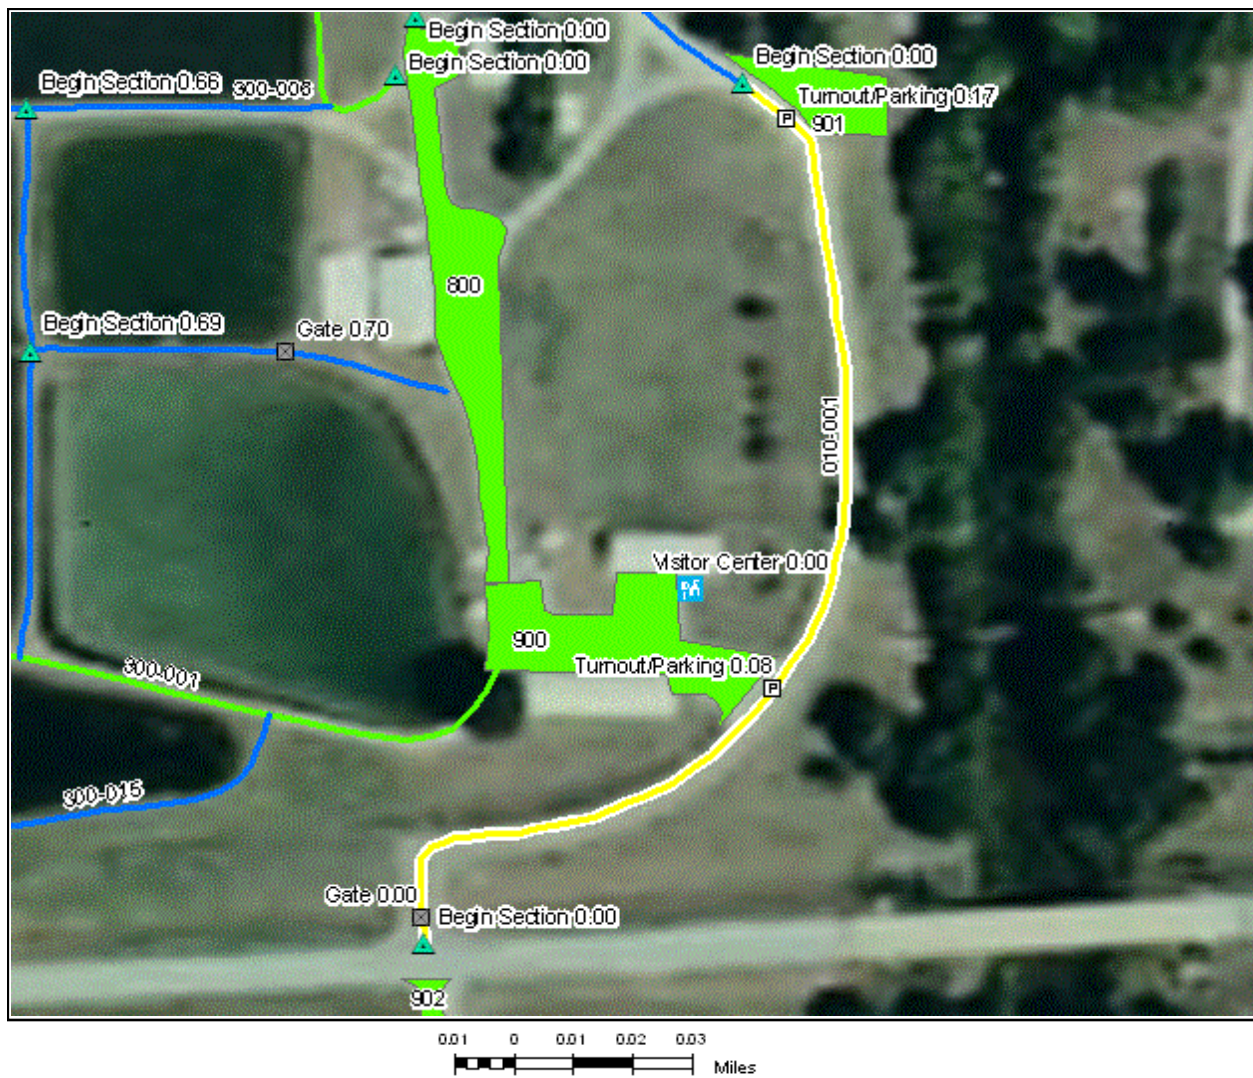
Route: 010 Entrance Road

Asset Number	10006373
Section Number	001
Section Length (miles)	0.18
Inspection Date	06/19/2009
<b>Section Information</b>	
Surface Type	Asphalt
Number of Lanes	2
Roadway Width (feet)	20.00
<b>Roadway Condition Information</b>	
Condition	Fair
Remaining Service Life (years)	8
Cost Estimate	17,500
CRV	193,700.00

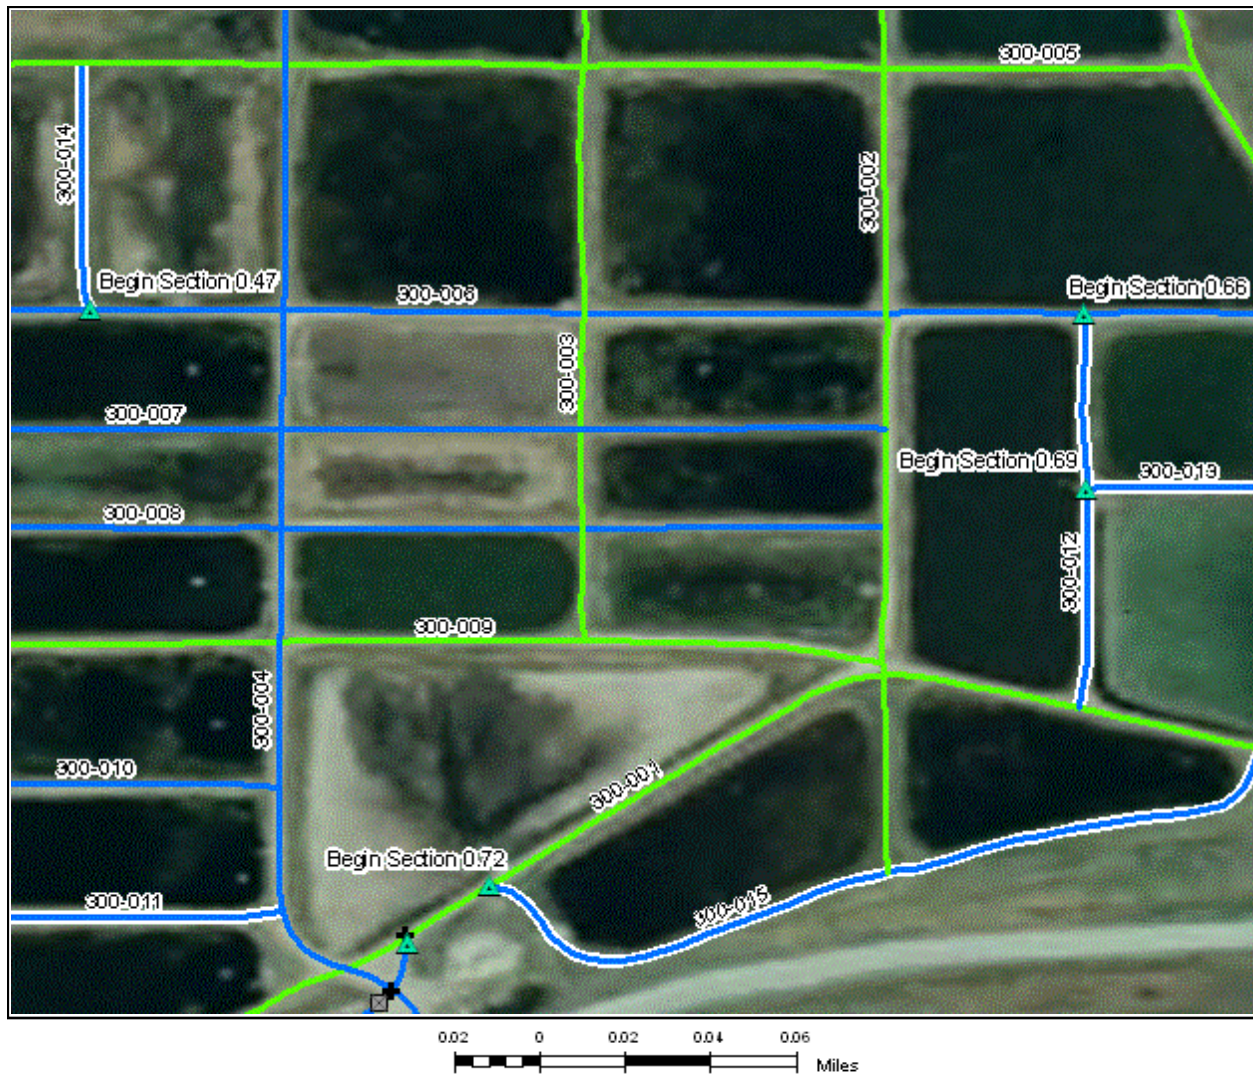
Route: 300 North Unit Ponds Road

Asset Number	10045763	10045763	10045763	10045763	10045763
Section Number	011	012	013	014	015
Section Length (miles)	0.08	0.09	0.06	0.06	0.17
Inspection Date	06/19/2009	06/19/2009	06/19/2009	06/19/2009	06/19/2009
<b>Section Information</b>					
Surface Type	Gravel	Gravel	Gravel	Gravel	Gravel
Number of Lanes	1	1	1	1	1
Roadway Width (feet)	10.00	10.00	10.00	10.00	10.00
<b>Roadway Condition Information</b>					
Condition	Excellent	Excellent	Excellent	Excellent	Excellent
Remaining Service Life (years)	9	8	9	9	9
Cost Estimate	0	0	0	0	0
CRV	48,100.00	56,700.00	36,100.00	35,500.00	105,000.00

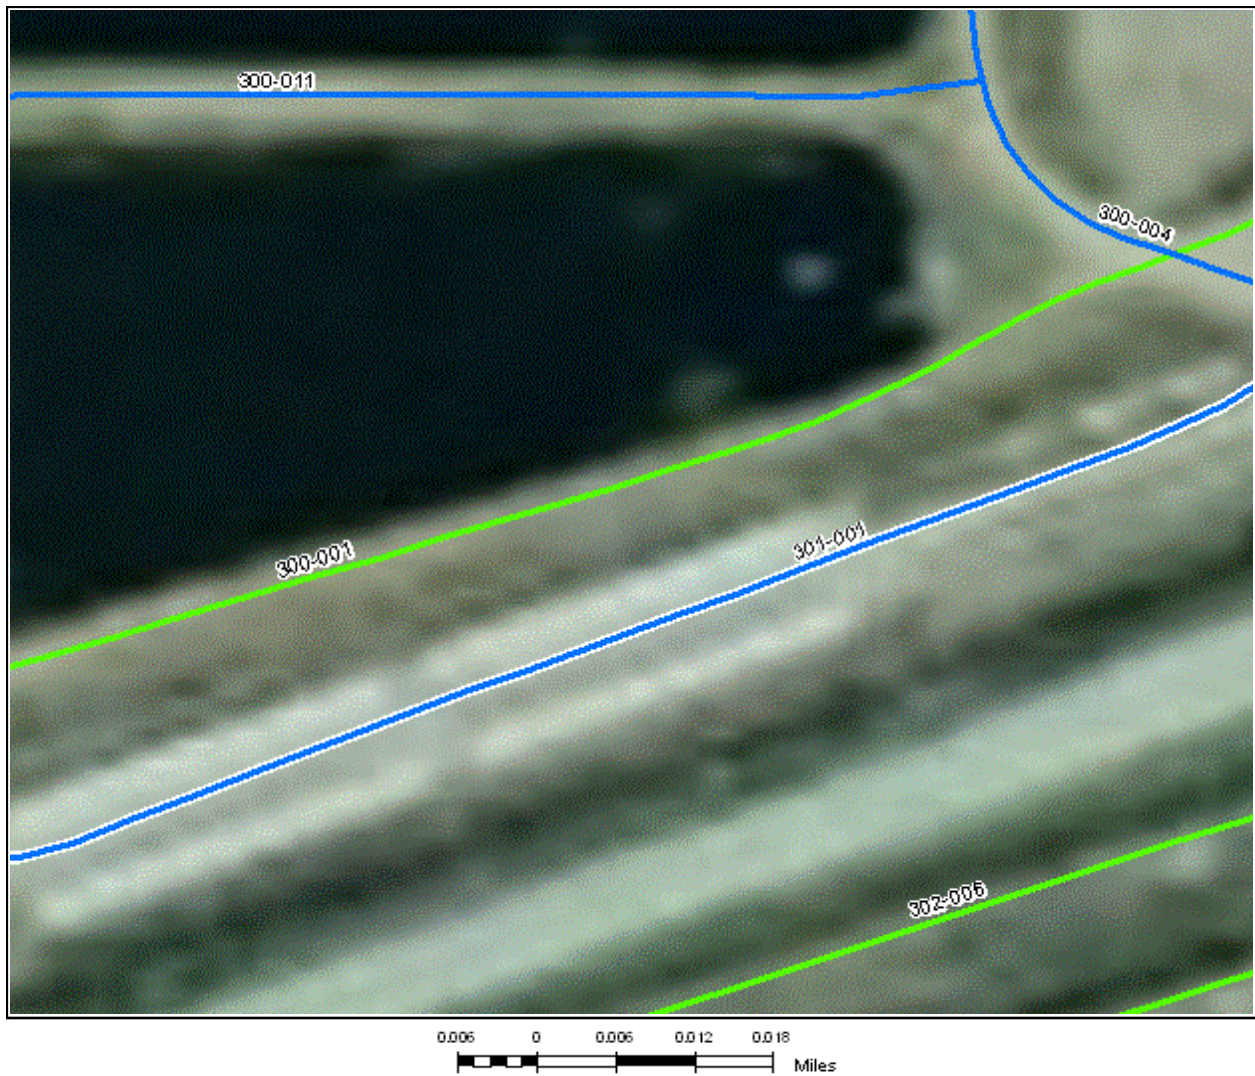
Route: 301 Raceway Road

Asset Number	10045763
Section Number	001
Section Length (miles)	0.12
Inspection Date	06/19/2009
<b>Section Information</b>	
Surface Type	Gravel
Number of Lanes	1
Roadway Width (feet)	10.00
<b>Roadway Condition Information</b>	
Condition	Excellent
Remaining Service Life (years)	9
Cost Estimate	0
CRV	73,300.00

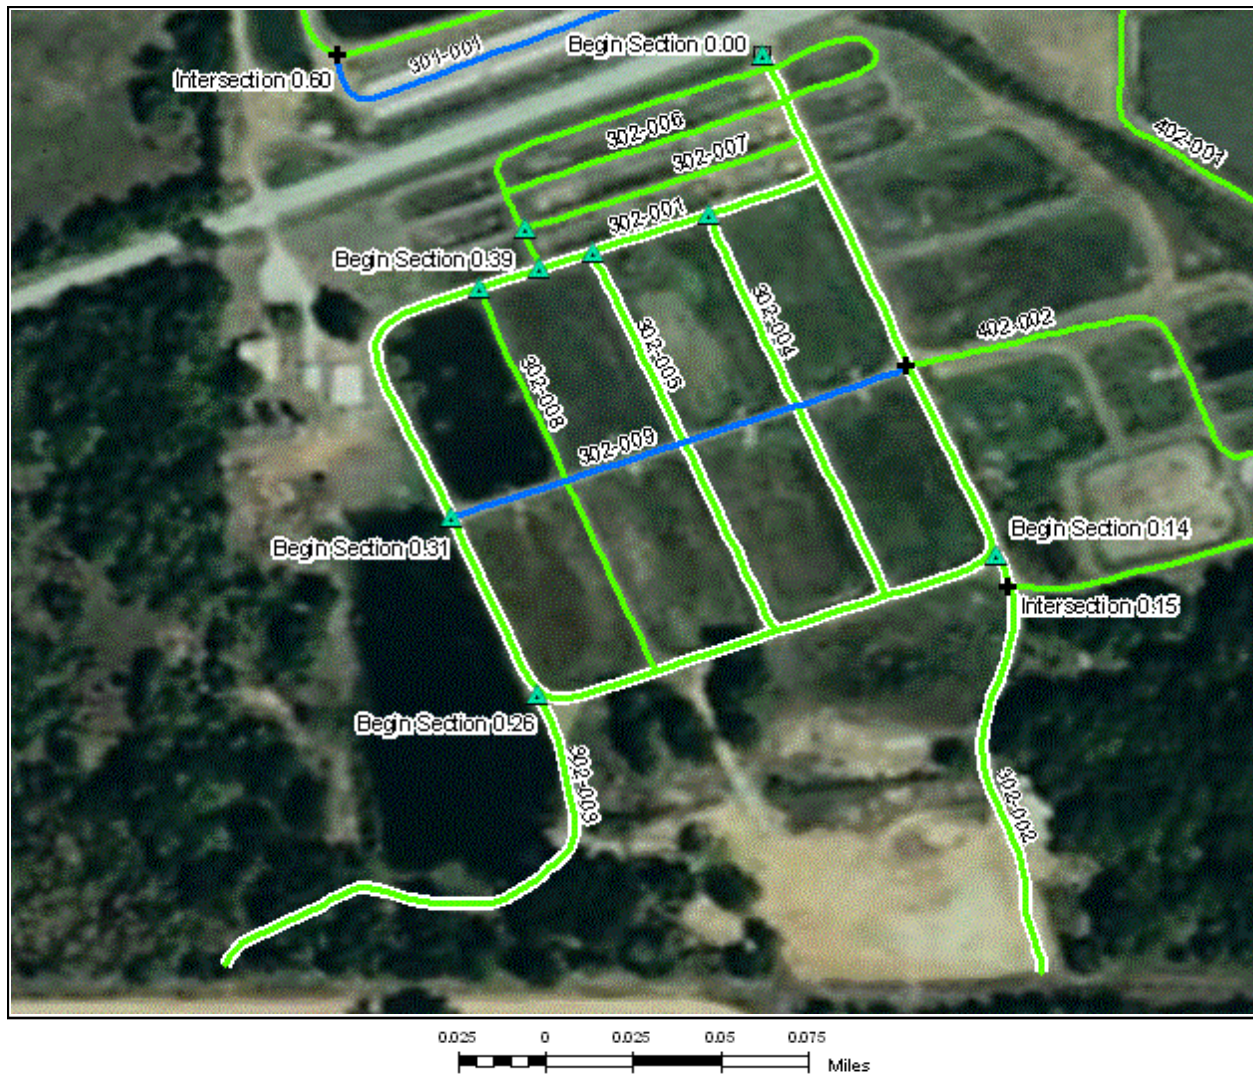
Route: 302 South Unit Ponds Road

Asset Number	10045763	10045763	10045763	10045763	10045763
Section Number	001	002	003	004	005
Section Length (miles)	0.48	0.12	0.14	0.11	0.11
Inspection Date	06/19/2009	06/19/2009	06/19/2009	06/19/2009	06/19/2009
<b>Section Information</b>					
Surface Type	Gravel	Gravel	Gravel	Gravel	Gravel
Number of Lanes	1	1	1	1	1
Roadway Width (feet)	10.00	10.00	10.00	10.00	10.00
<b>Roadway Condition Information</b>					
Condition	Good	Good	Good	Good	Good
Remaining Service Life (years)	7	5	5	7	7
Cost Estimate	700	200	200	200	200
CRV	302,500.00	75,500.00	87,100.00	72,000.00	71,900.00

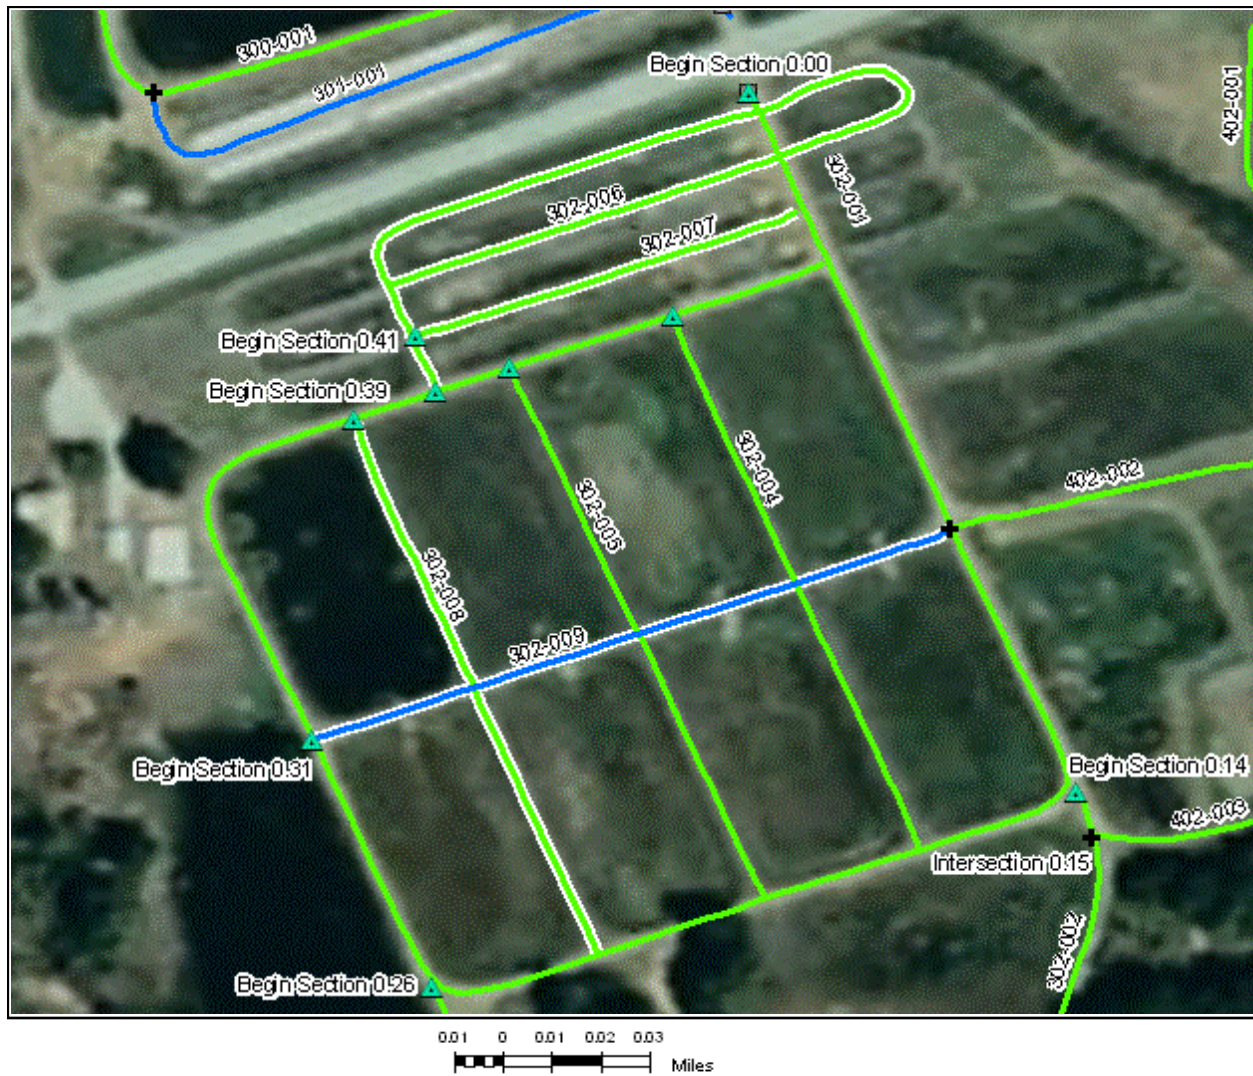
Route: 302 South Unit Ponds Road

Asset Number	10045763	10045763	10045763	10045763
Section Number	006	007	008	009
Section Length (miles)	0.22	0.07	0.11	0.11
Inspection Date	06/19/2009	06/19/2009	06/19/2009	06/19/2009
<b>Section Information</b>				
Surface Type	Gravel	Gravel	Gravel	Gravel
Number of Lanes	1	1	1	1
Roadway Width (feet)	10.00	10.00	10.00	10.00
<b>Roadway Condition Information</b>				
Condition	Good	Good	Good	Excellent
Remaining Service Life (years)	7	7	7	9
Cost Estimate	300	100	200	0
CRV	141,000.00	42,400.00	72,100.00	71,600.00

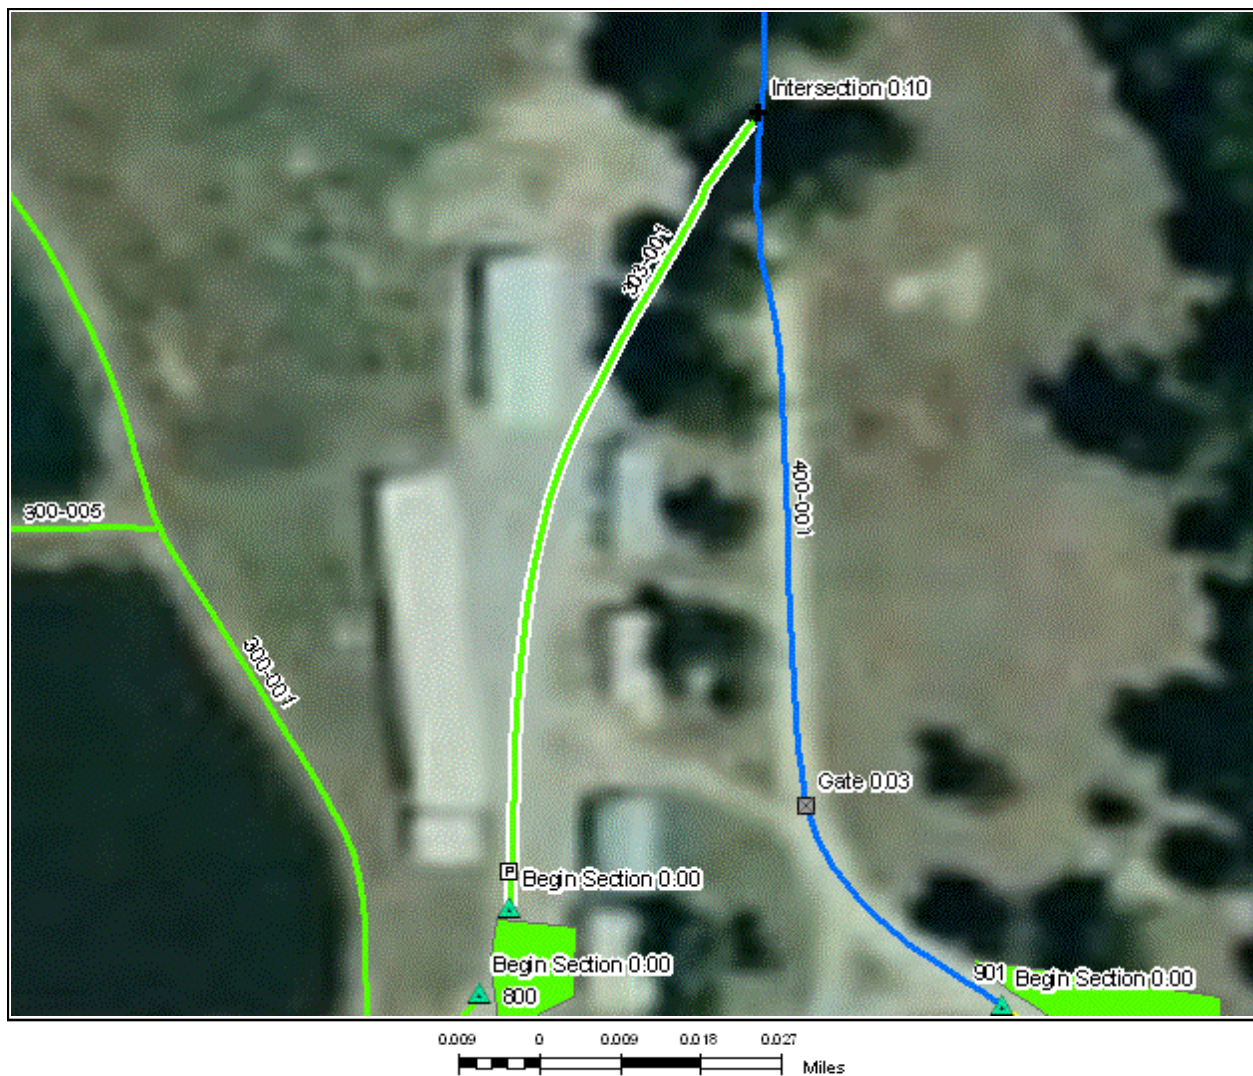
Route: 303 Shop Road

Asset Number	10045763
Section Number	001
Section Length (miles)	0.09
Inspection Date	06/19/2009
<b>Section Information</b>	
Surface Type	Gravel
Number of Lanes	1
Roadway Width (feet)	14.00
<b>Roadway Condition Information</b>	
Condition	Good
Remaining Service Life (years)	7
Cost Estimate	100
CRV	56,300.00

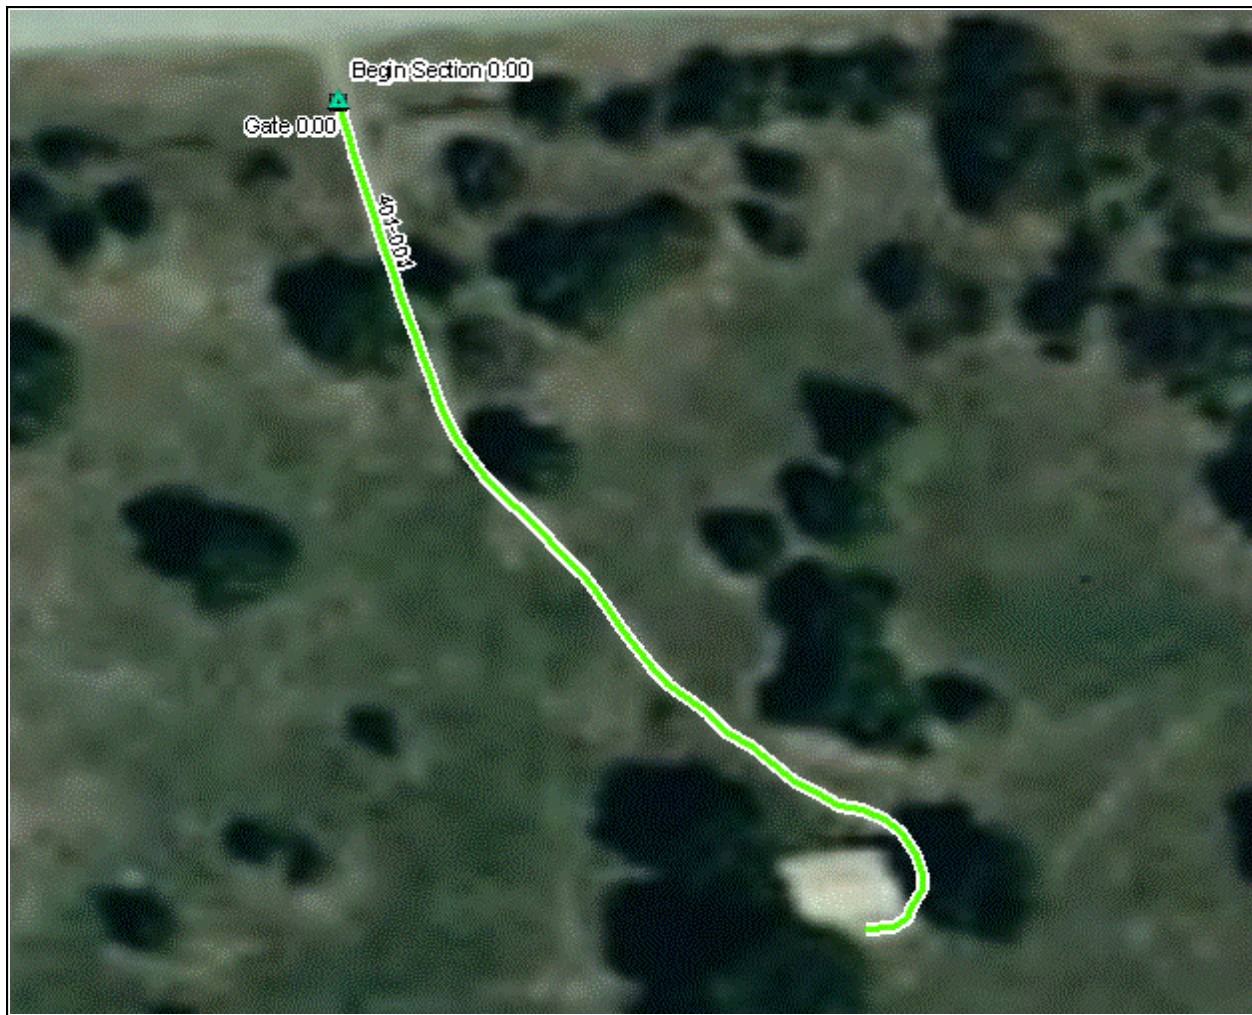
Route: 401 Boat Barn Road

Asset Number	10045763
Section Number	001
Section Length (miles)	0.14
Inspection Date	06/19/2009
<b>Section Information</b>	
Surface Type	Gravel
Number of Lanes	1
Roadway Width (feet)	8.00
<b>Roadway Condition Information</b>	
Condition	Good
Remaining Service Life (years)	7
Cost Estimate	200
CRV	89,900.00

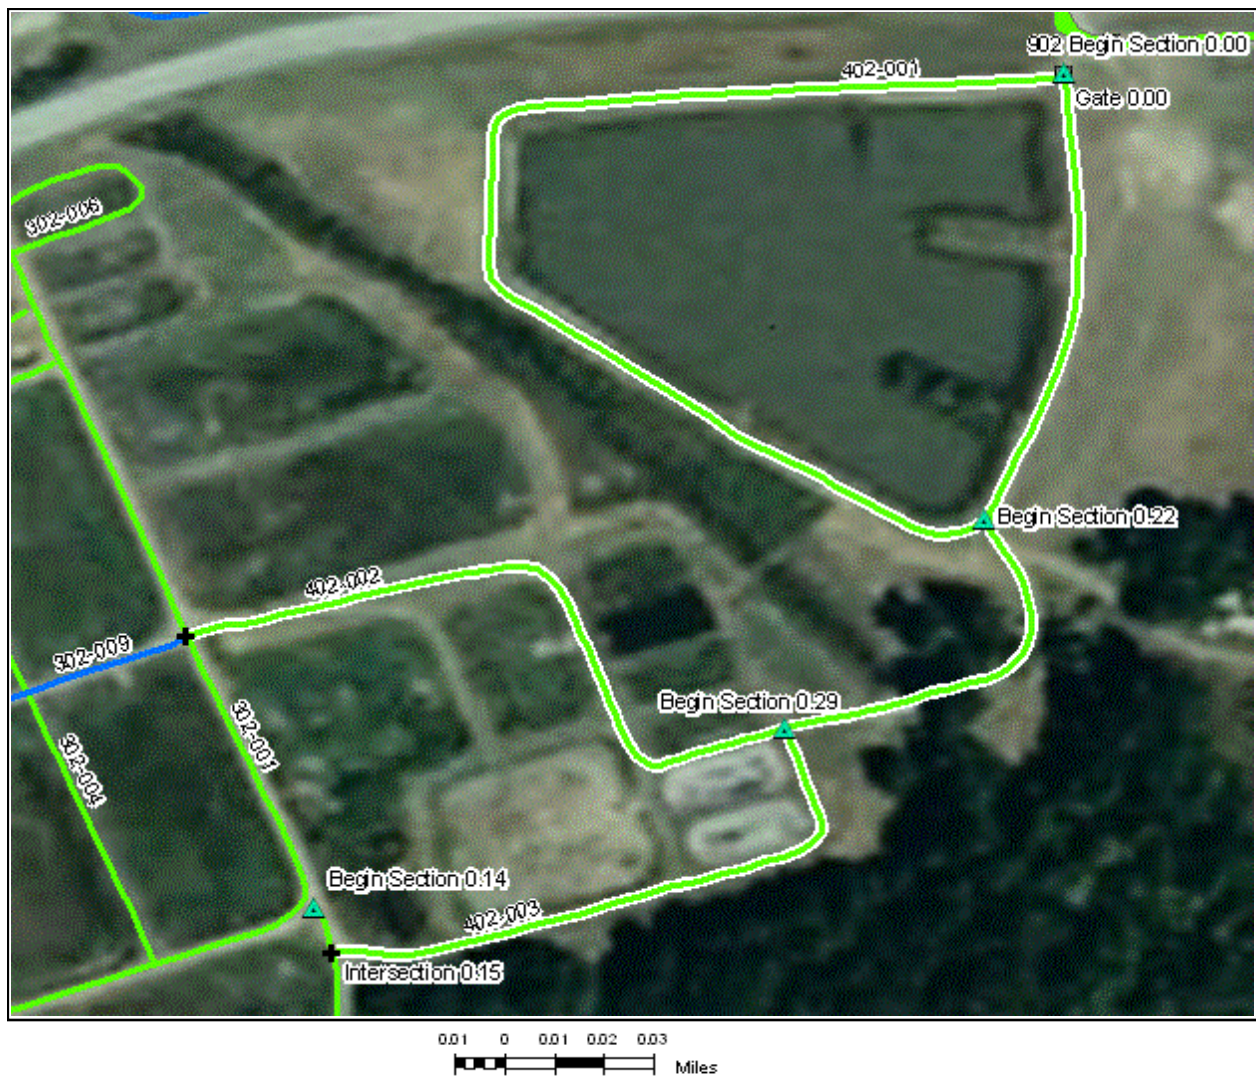
Route: 402 Southeast Unit Ponds Road

Asset Number	10045763	10045763	10045763
Section Number	001	002	003
Section Length (miles)	0.31	0.19	0.10
Inspection Date	06/19/2009	06/19/2009	06/19/2009
<b>Section Information</b>			
Surface Type	Native	Native	Gravel
Number of Lanes	1	1	1
Roadway Width (feet)	10.00	10.00	10.00
<b>Roadway Condition Information</b>			
Condition	Good	Good	Good
Remaining Service Life (years)	5	7	5
Cost Estimate	500	300	200
CRV	100,900.00	63,400.00	65,700.00

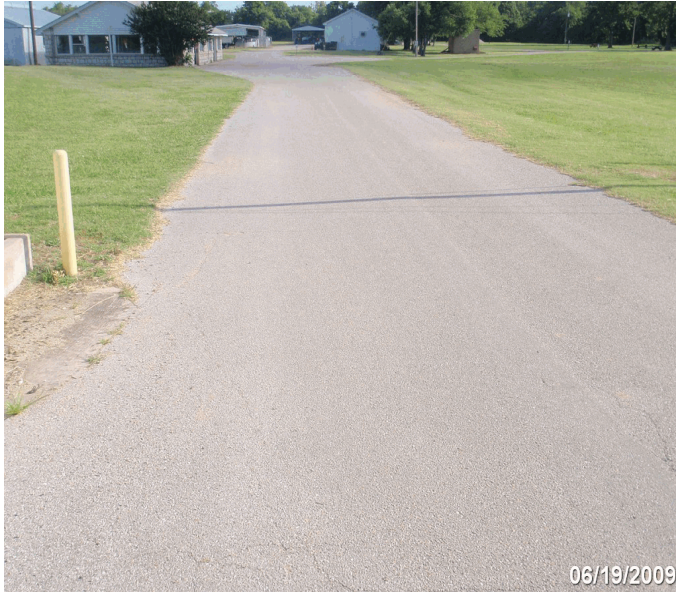
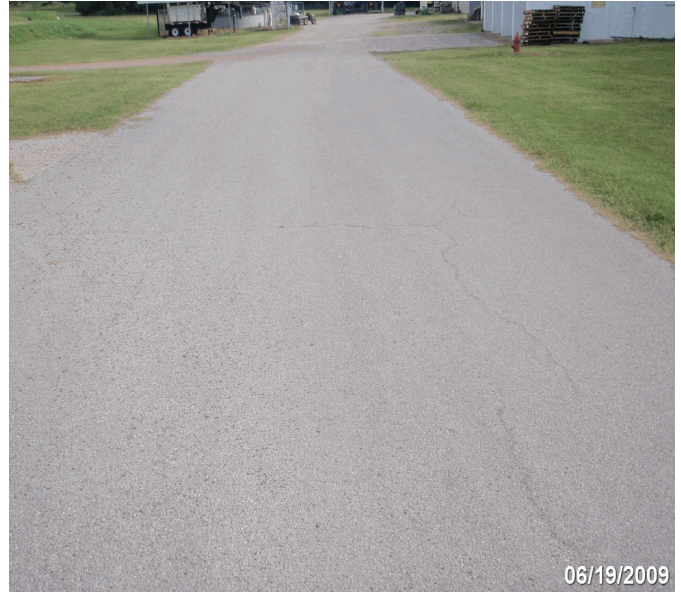
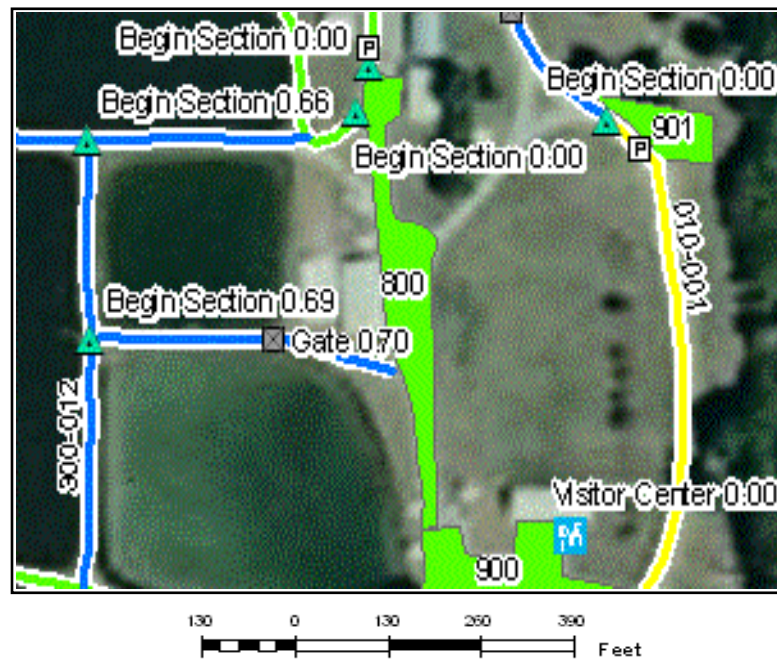
## 800: Shop Parking

Asset Number	Date Visited	Surface Type	Area (Sq Ft)	Condition	Cost to Improve
10006373	06/19/2009	Asphalt	14,338	Good	2,400

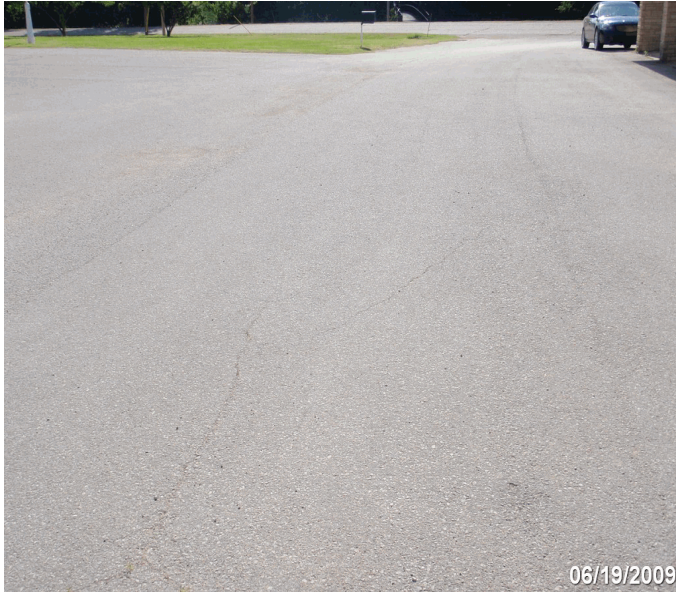
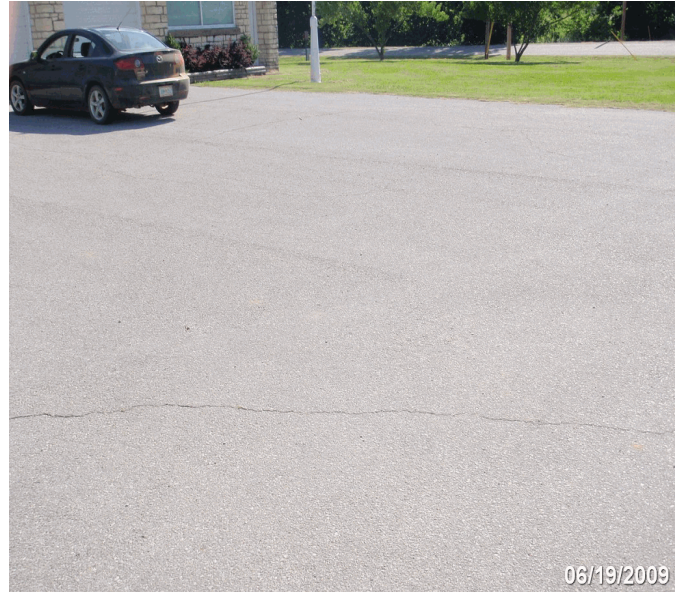
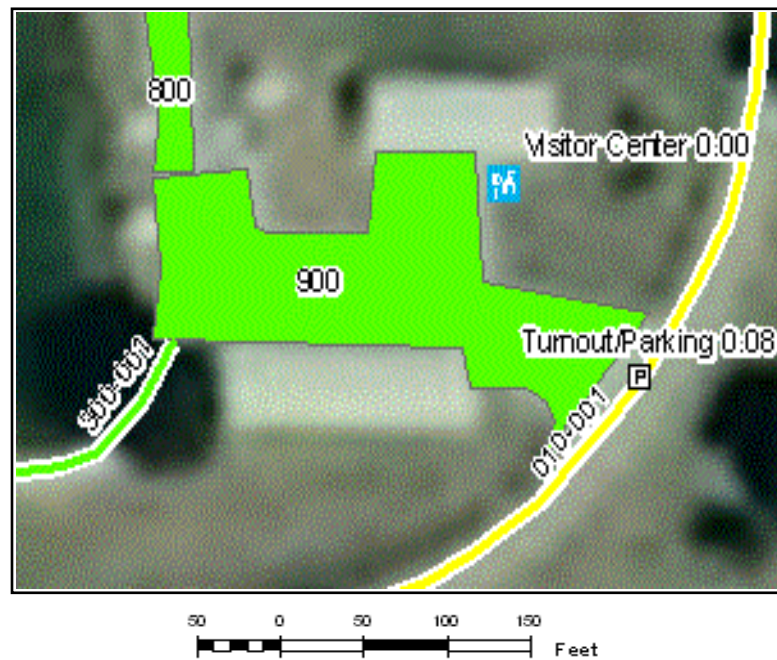
## 900: Headquarters Parking

Asset Number	Date Visited	Surface Type	Area (Sq Ft)	Condition	Cost to Improve
	06/19/2009	Asphalt	12,325	Good	2,100

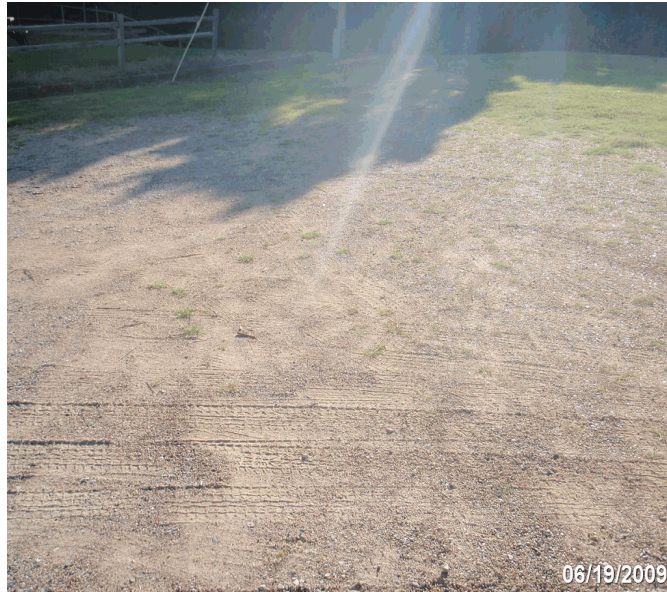
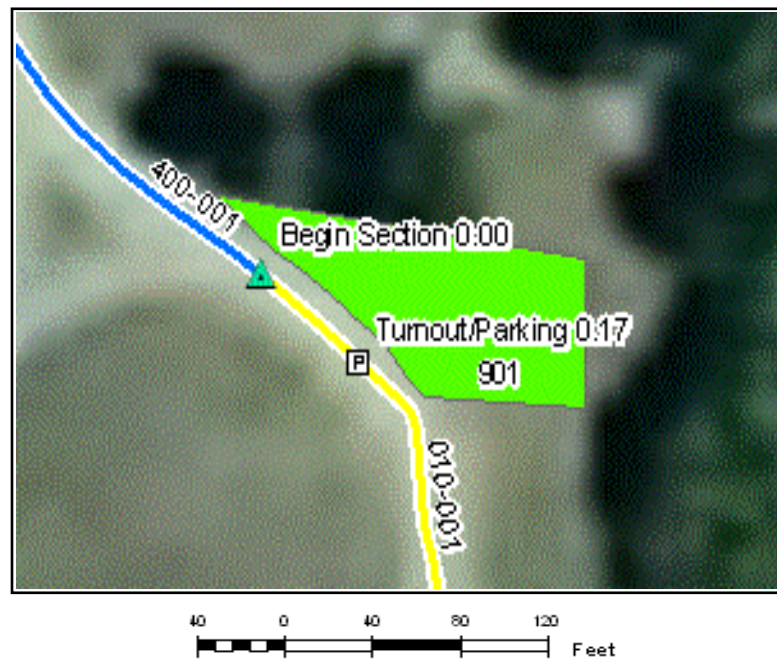
## 901: Visitor Kiosk Parking

Asset Number	Date Visited	Surface Type	Area (Sq Ft)	Condition	Cost to Improve
	06/19/2009	Gravel	4,489	Good	600

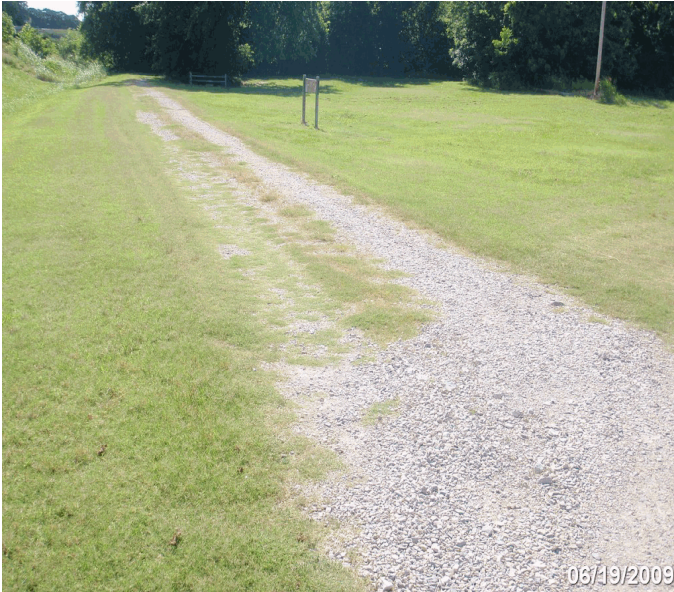
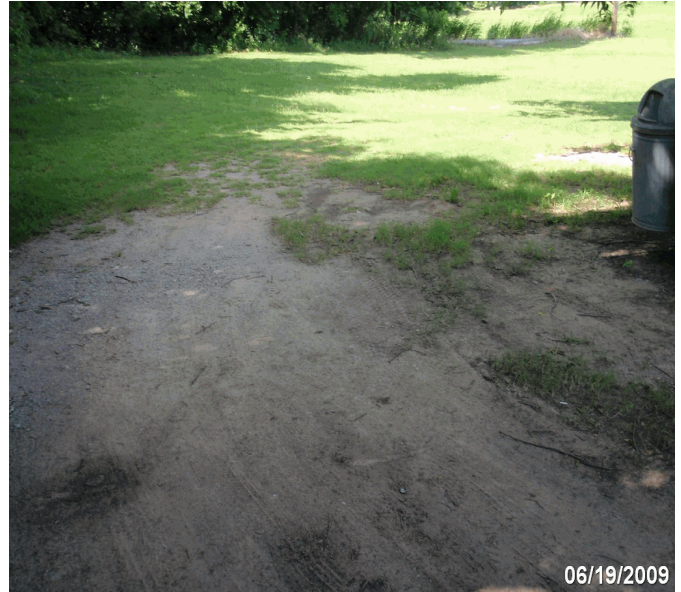
## 902: Fishing/Picnic Parking

Asset Number	Date Visited	Surface Type	Area (Sq Ft)	Condition	Cost to Improve
	06/19/2009	Gravel	9,834	Good	1,400
